## INLETS WHY THEY FAIL

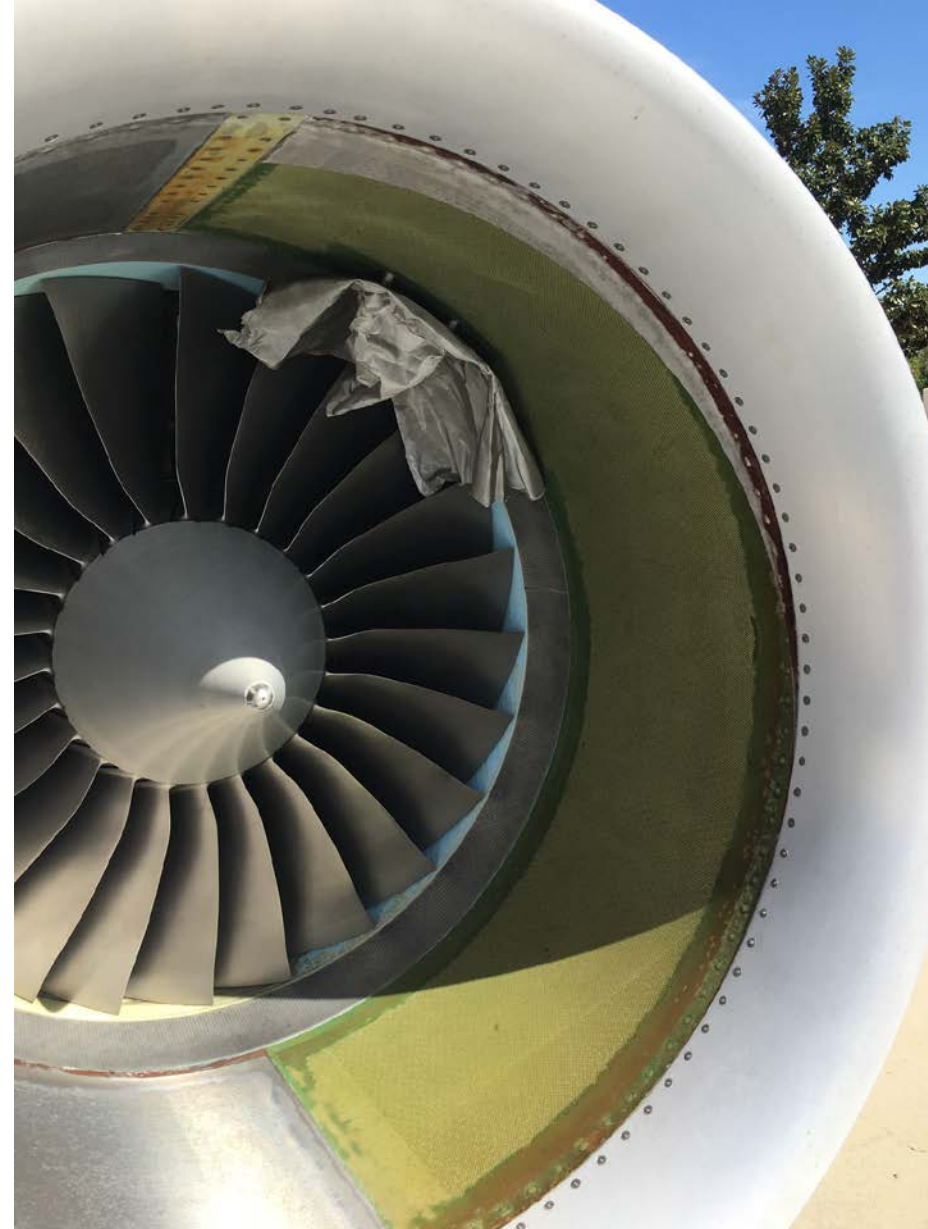
Lip Skin corrosion starting  
under the countersink of  
the Hi-Loks

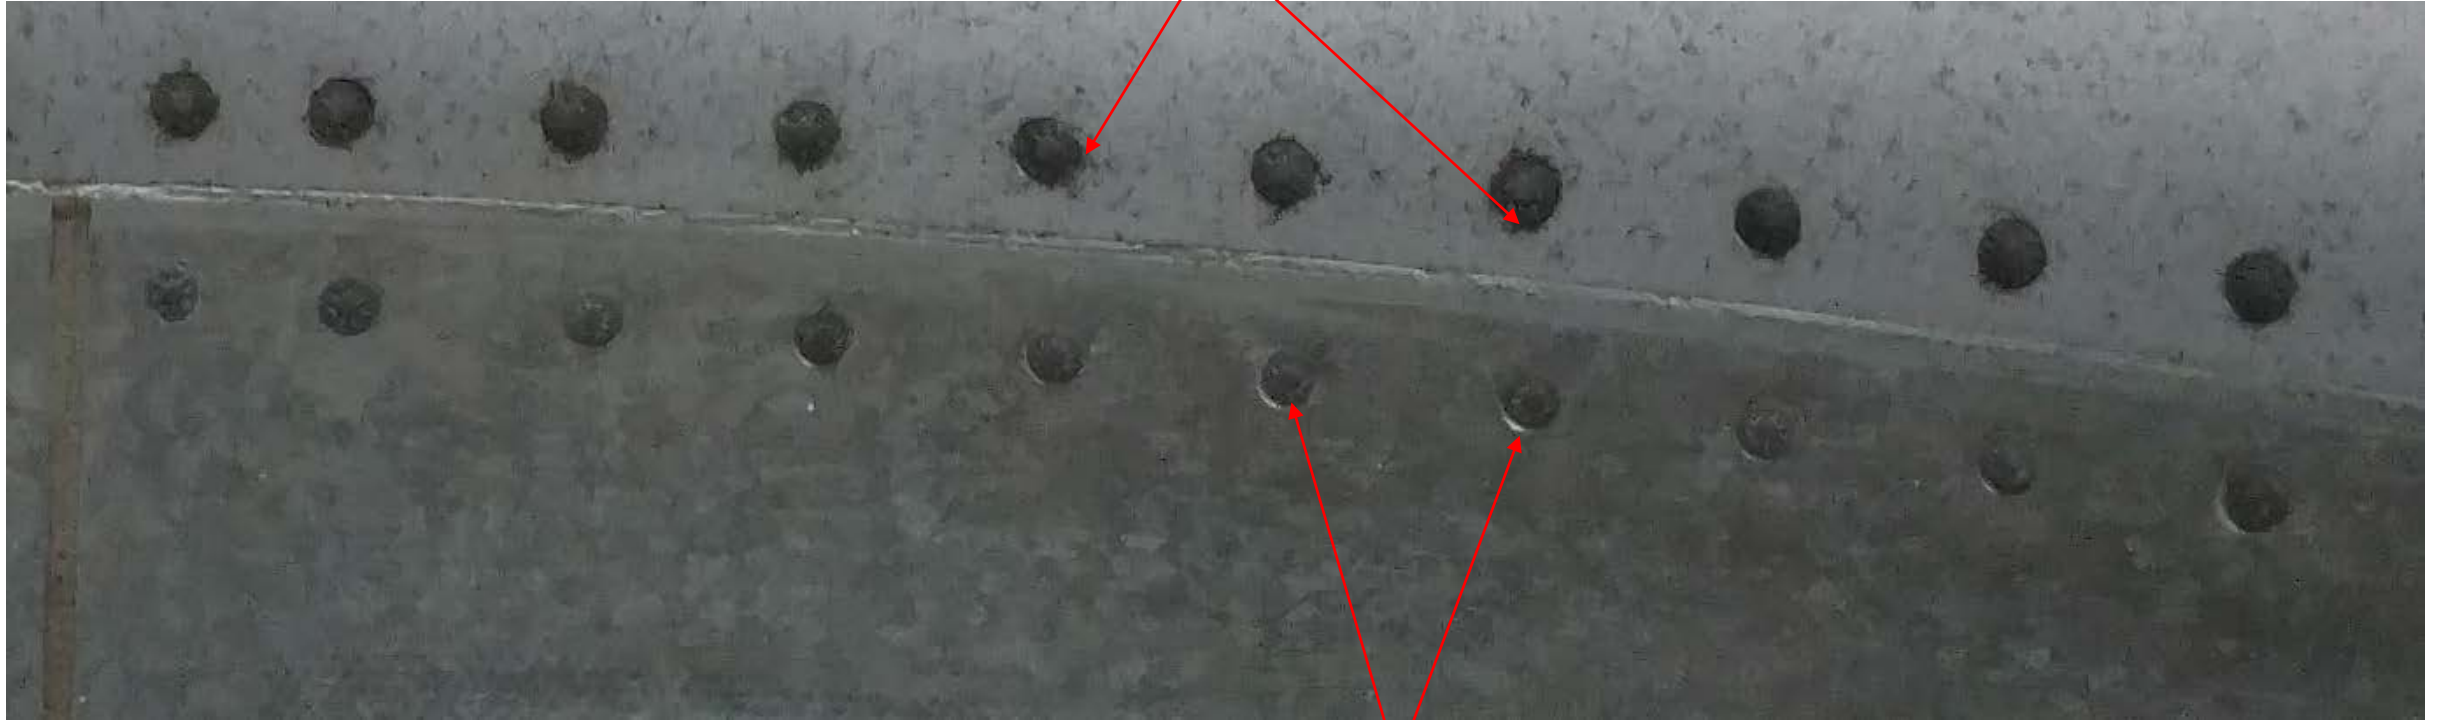
Corrosion of the inner Barrel is causing the barrel  
to Bulkhead attachment Hi-Lok pins to start pulling  
through into the surface due to the material  
expanding as the corrosion build up.

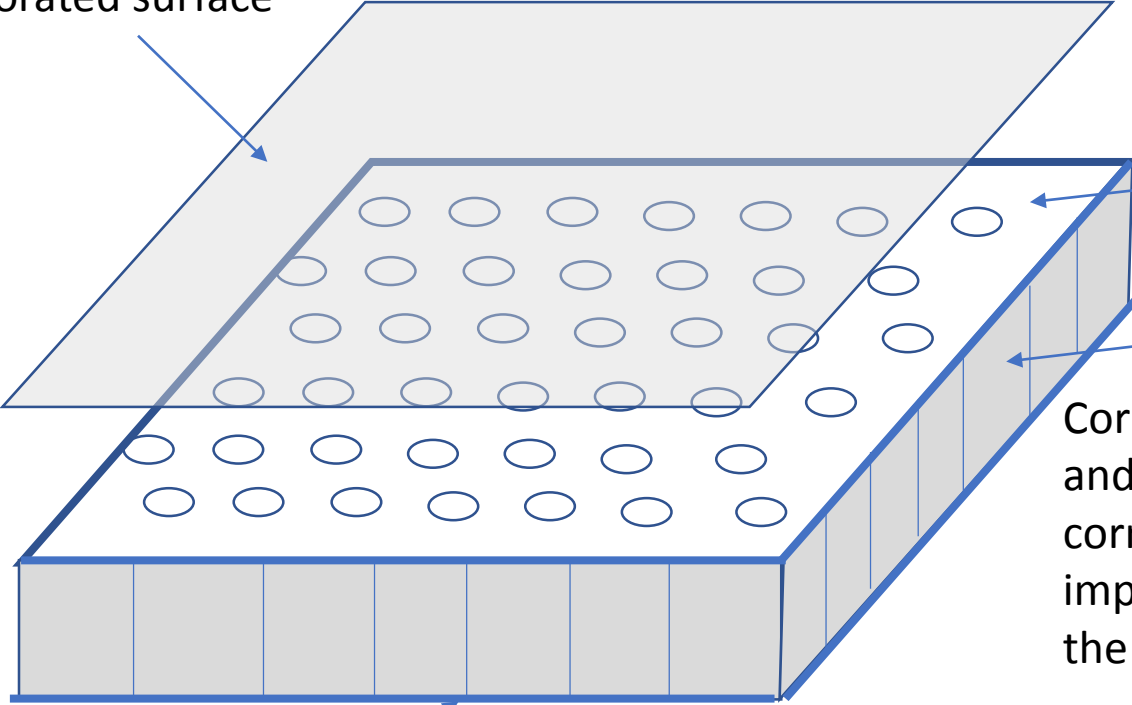
Stainless wire cloth bonded to inner perforated surface

2024 T3 Perforated Aluminum Inner Barrel Skin

Corrosion of the inner barrel surface is caused by moisture and accelerated by salt or chemicals such as acid rain. The corrosion gets into the perforated holes making it impossible to remove. So any attempt to repair by cleaning the surface and bonding new screen will fail in 1-3 years.

Additional problems occur as the Stainless Steel 'Screen' and Aluminum perforated face sheet are incompatible, and once the adhesive bond break downs, Galvanic corrosion of the aluminum will accelerate the degradation.

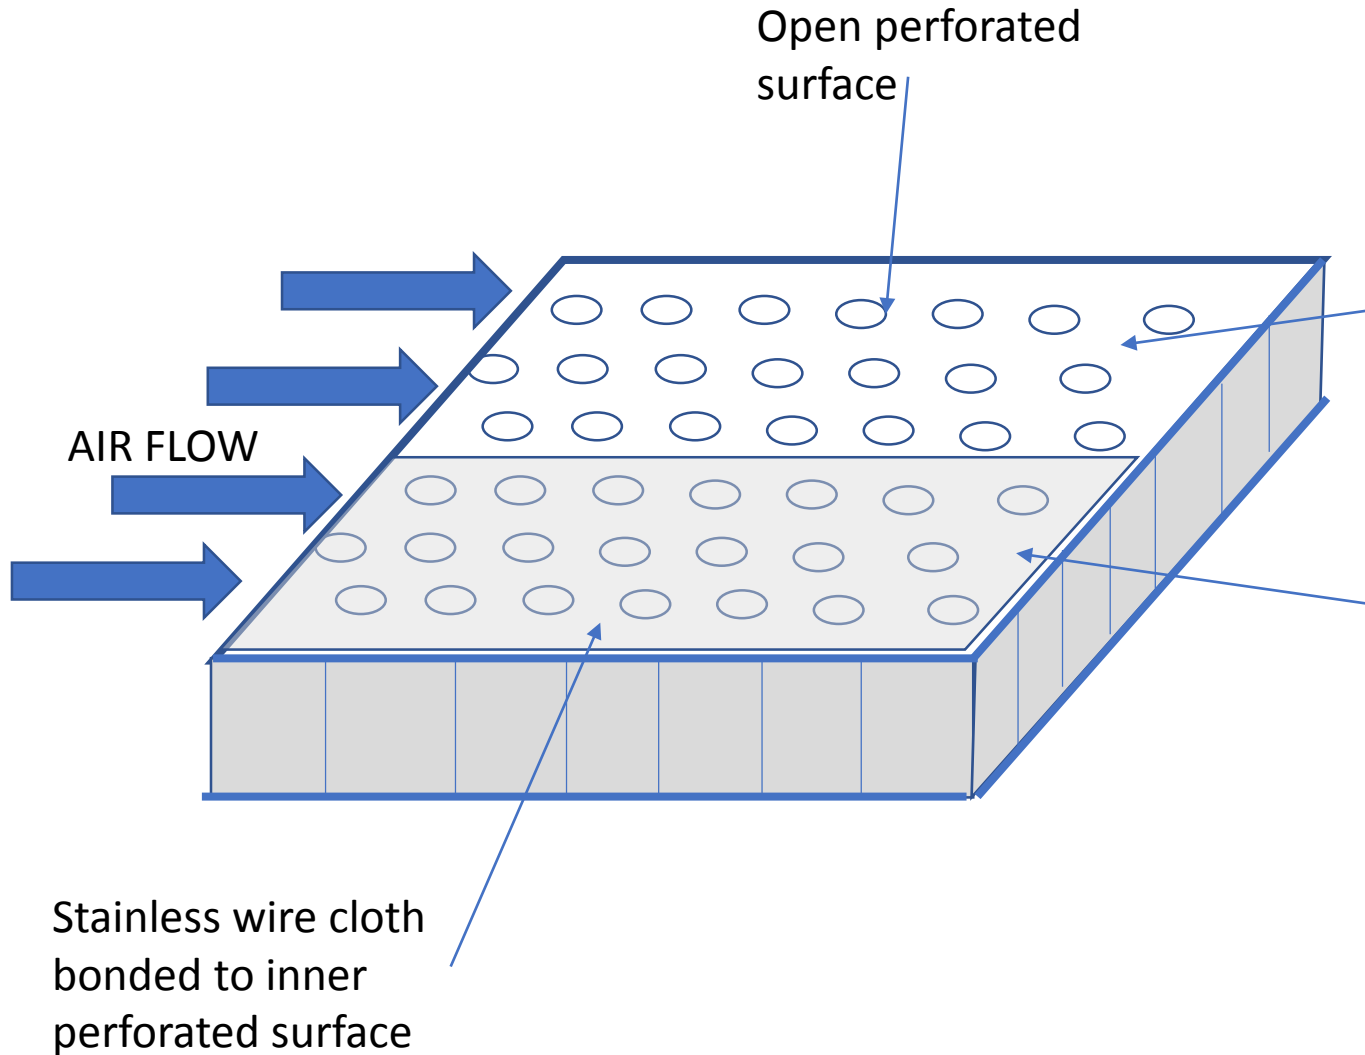
Earlier generation Inlets with noise treatment had an inner barrel with an open perforated surface, the effect of airflow over the surface creates a venture effect and sucks moisture out.

Later generation Inlets added the 'Acoustic Screen' which acts as a filter and increases the noise attenuation properties by as much as 30%.

The Screen is permeable so moisture can pass through it, but with no open holes the effects of the airflow no longer creates a venture effect so moisture remains trapped which accelerates the onset of corrosion.
