## INLETS WHY THEY FAIL

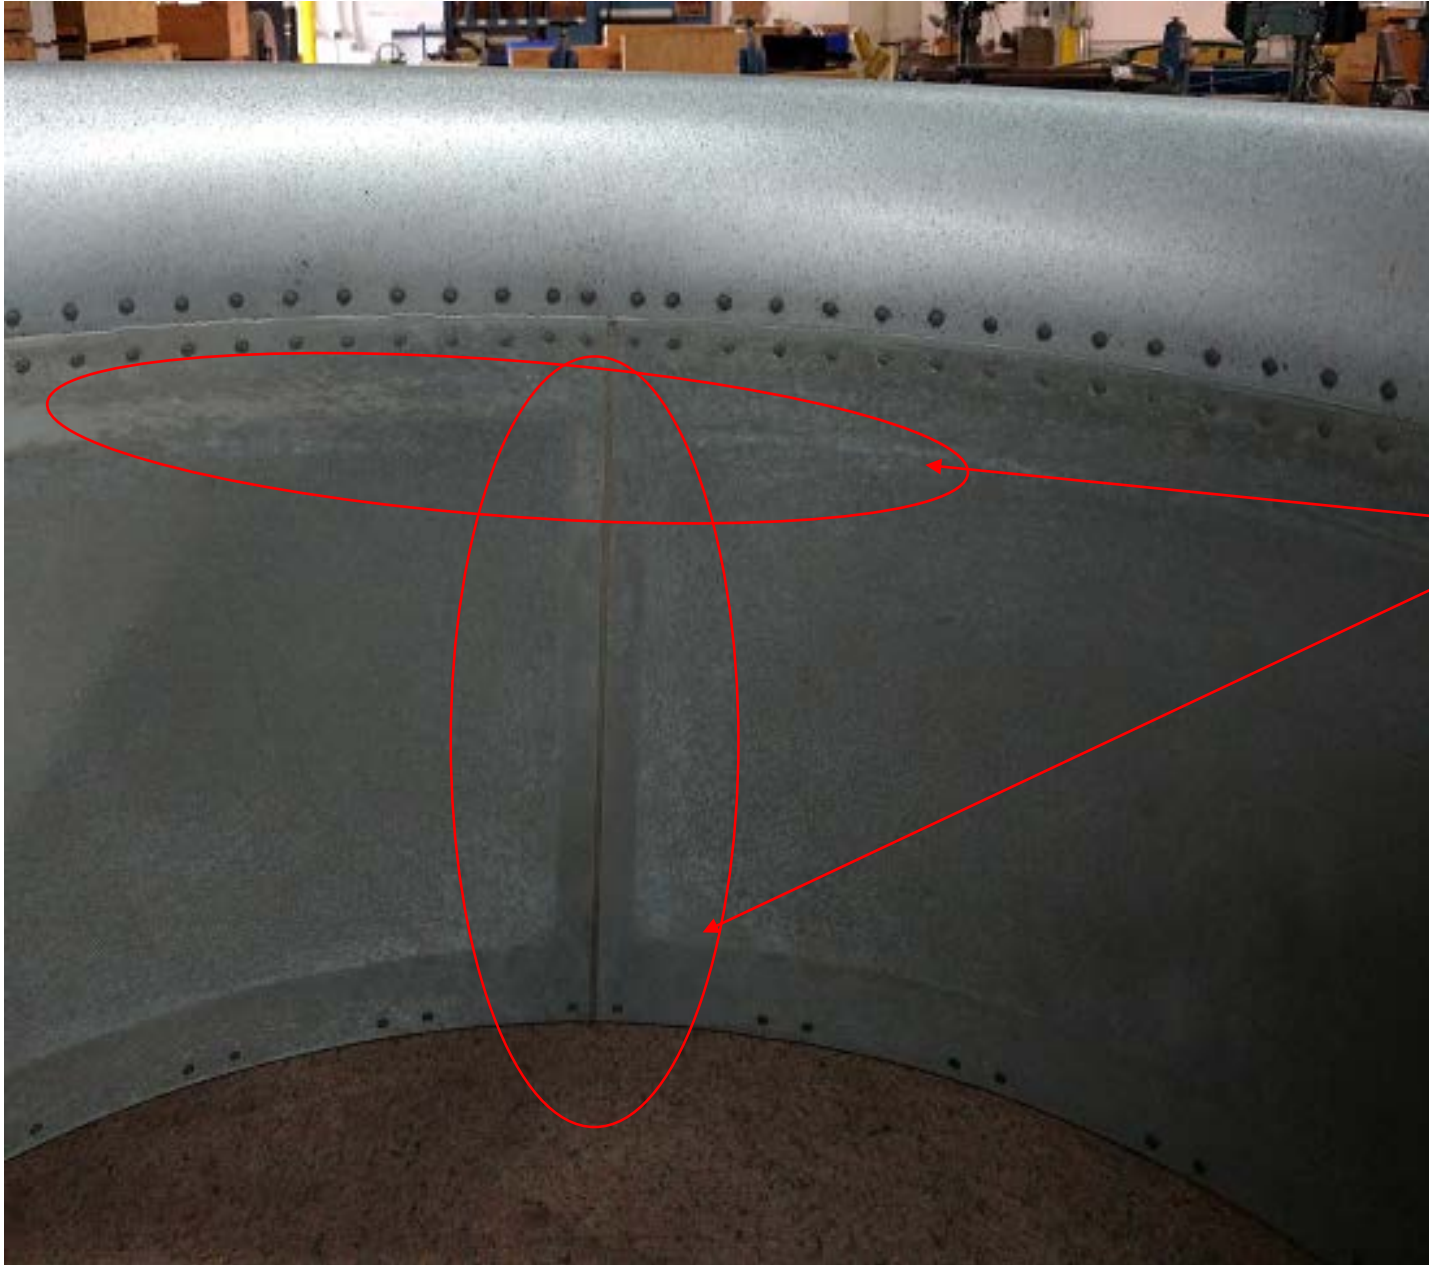
The areas that show the WHITE or lighter appearance have corrosion to the inner skin. The corrosion leads to disbond of the internal Screen, which will eventually lift and peel off. See Slide 2.

Once corrosion starts, the dissimilar metals, Aluminum Barrel to Stainless Steel Screen will cause Galvanic corrosion and accelerate the rate of deterioration.
